# SEM – Invaluable and practical tool for casting defect analysis before a DOE

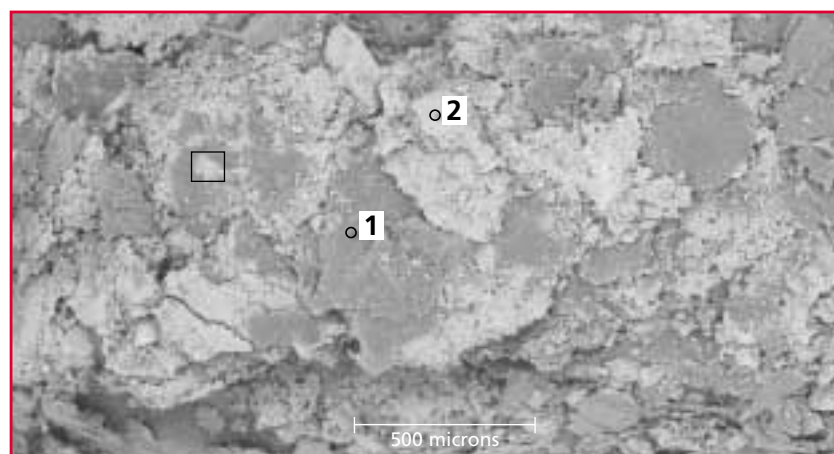
Figure 1 shows the typical shape and microstructure of the surface of the silicon carbide crucible wall. This structure is composed of two phases shown in dark (area 1) and white colours (area 2). EDX spectrum analysis of the dark and white areas revealed the concentration of carbon and silicon elements respectively. Figures 2 and 3 have their respective EDX spectrum embedded into the photograph. Figure 2 shows that the white area is rich in silicon, while figure 3 shows that the dark area is rich in carbon. These types of particles, if present in the casting, would be considered as exogenous inclusions. The individual high concentrations of silicon, and carbon may be attributable to the glazed coated crucible. It is known that such glazed coating often contains metallic silicon and graphite to reduce oxidation and improve non-wetting properties of the crucible.

Figure 1: SEM image from a silicon carbide crucible wall section showing two different areas.

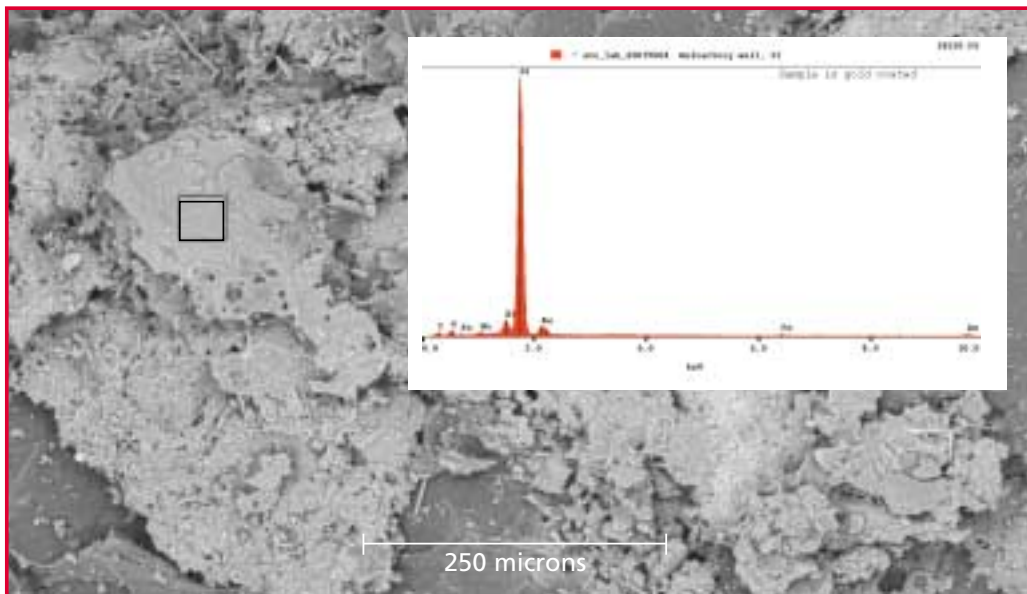
Figure 2: SEM image, and EDX spectrum of area 2 (white area from figure 1) showing high concentration of silicon.

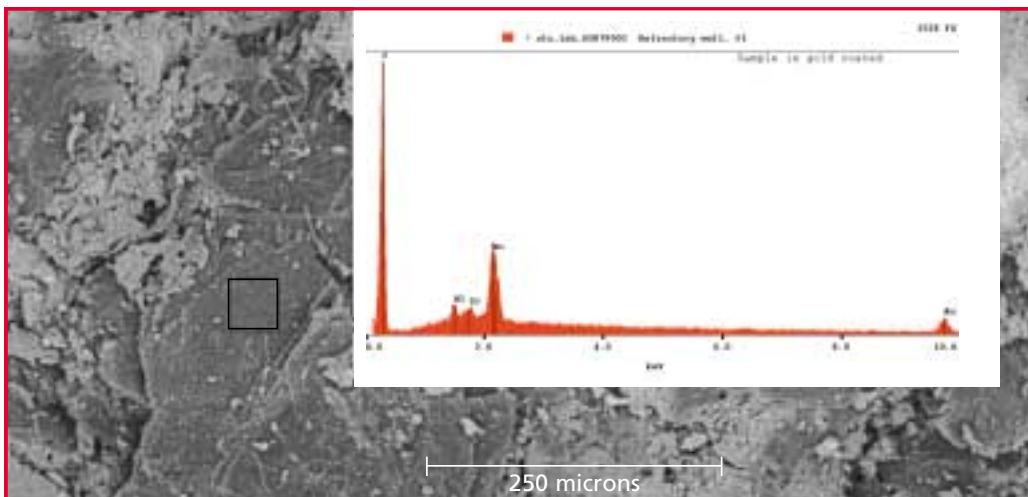
Figure 3: SEM image, and EDX spectrum of area 1 (dark area from figure 1) showing high concentration of carbon.

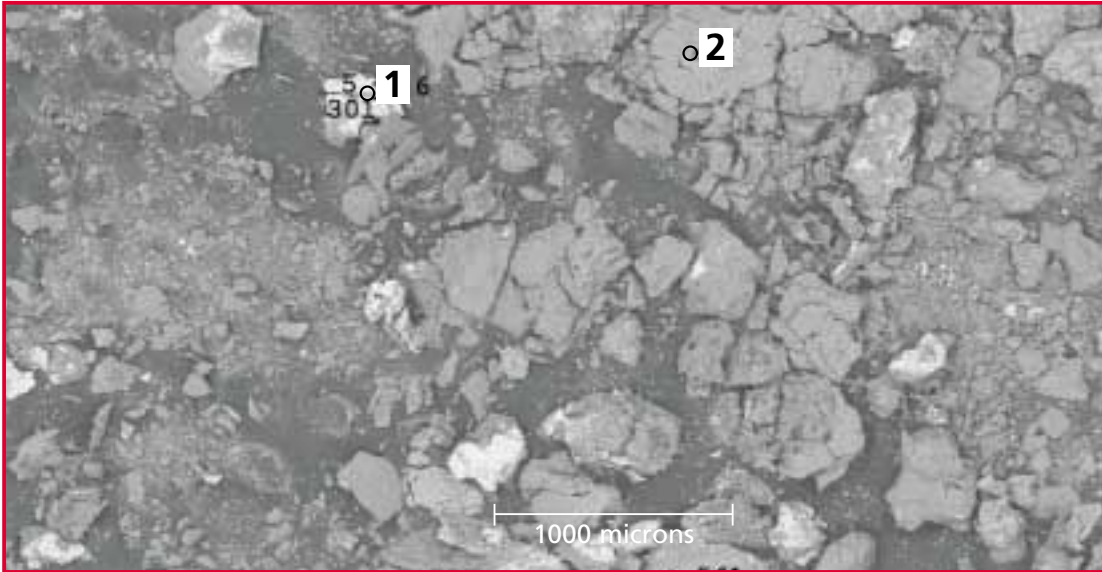
Figure 4 shows the typical morphology of the dross layer floating on the top surface of the molten metal bath. This condition would represent an improperly skimmed metal. Two different colours: white (area 1) and gray (area 2) represent typical major dross particles. The EDX spectrum of the white area is shown in Figure 5. As it can be seen, the white particles are chlorine, potassium, aluminium and magnesium rich particles resulting from fluxing salts. These particles would be present as non-metallic inclusions in the casting. The EDX spectrum of the gray particle is embedded in Figure 6. Figure 6 shows that the gray area is made mainly out of aluminium with some traces of magnesium and potassium.

Figure 4: SEM image from dross layer floating on top of the surface of the molten metal inside the crucible furnace.

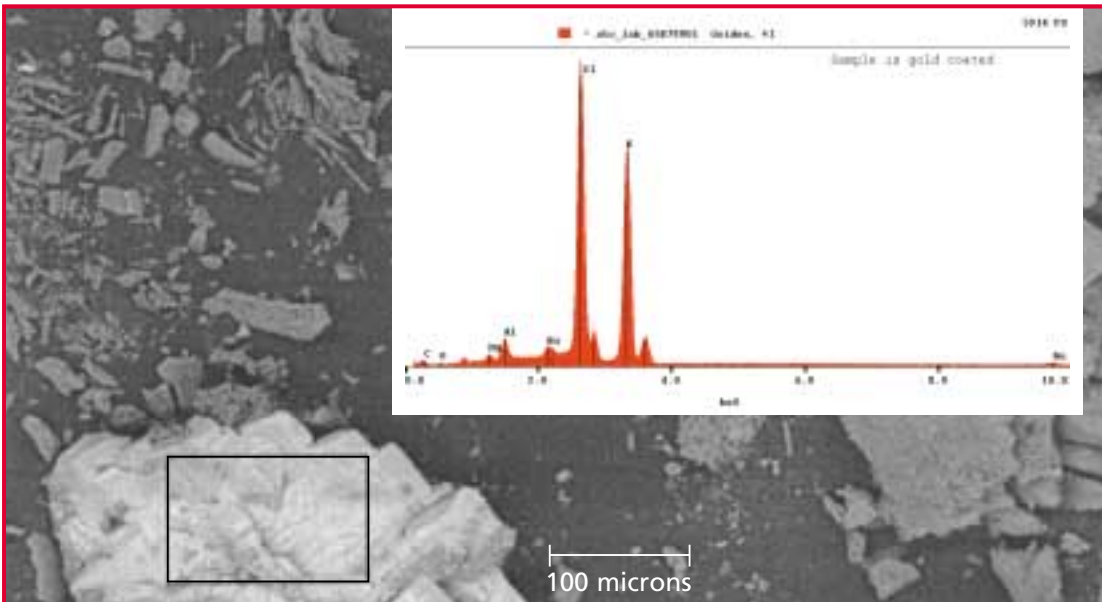
Figure 5: SEM image, and EDX spectrum of area 1 (white area from figure 4) showing chlorine, potassium, aluminium and magnesium rich particles.

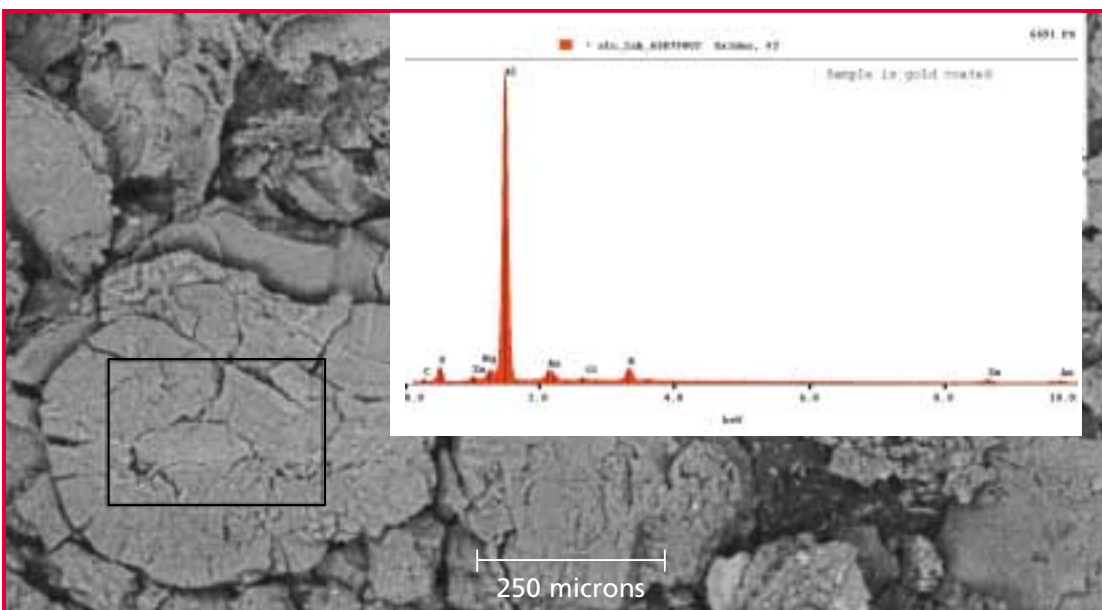
Figure 6: SEM image, and EDX spectrum of area 2 (dark area from figure 4) showing aluminium and traces of magnesium, and potassium particles.

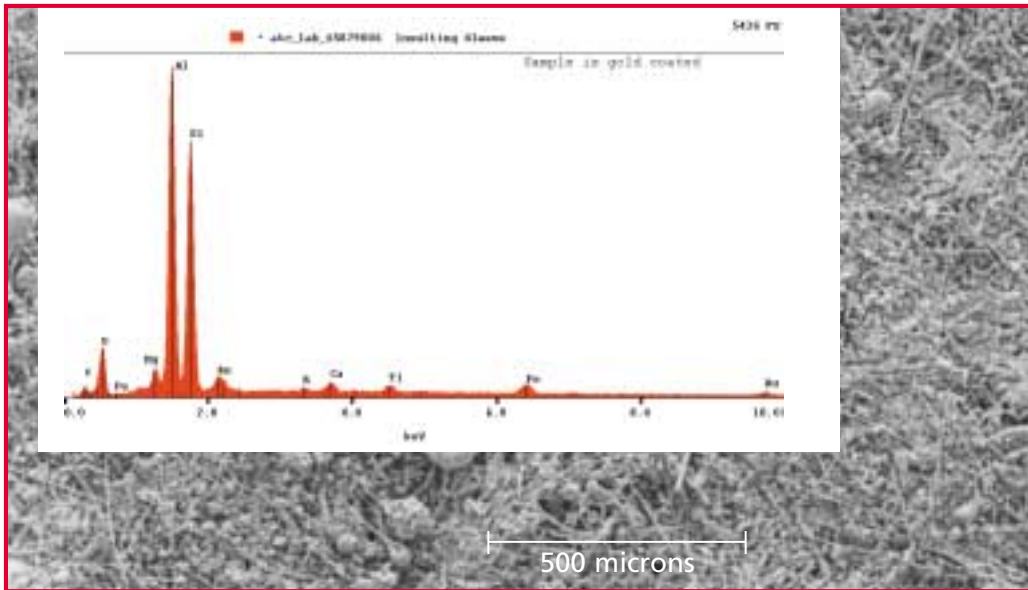
The morphology of the refractory material of the insulating sleeve is depicted in Figure 7. This material does not melt down during pouring. If this material would get entrapped into the casting during pouring, the defect in the casting would look like the structure shown in this figure.

Figure 7: SEM image, and EDX spectrum of the insulating sleeve structure.

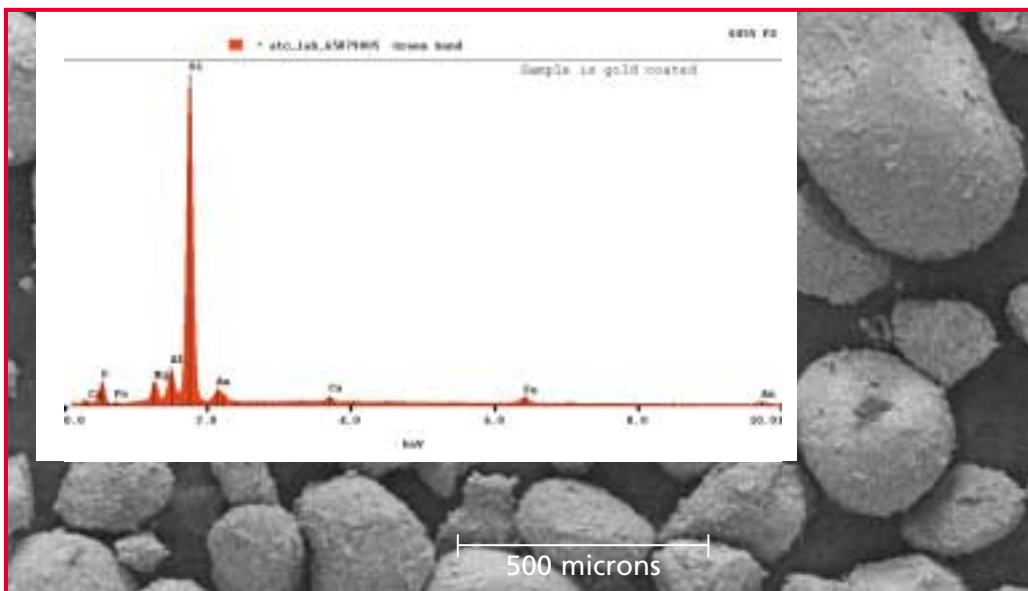
Figure 8 depicts the typical green sand grains that are part of the green sand mould. The chemical analysis shows that the sand is mainly silica base sand.

Figure 8: SEM image, and EDX spectrum of green sand grains coming from the faces of the cope and drag moulds.

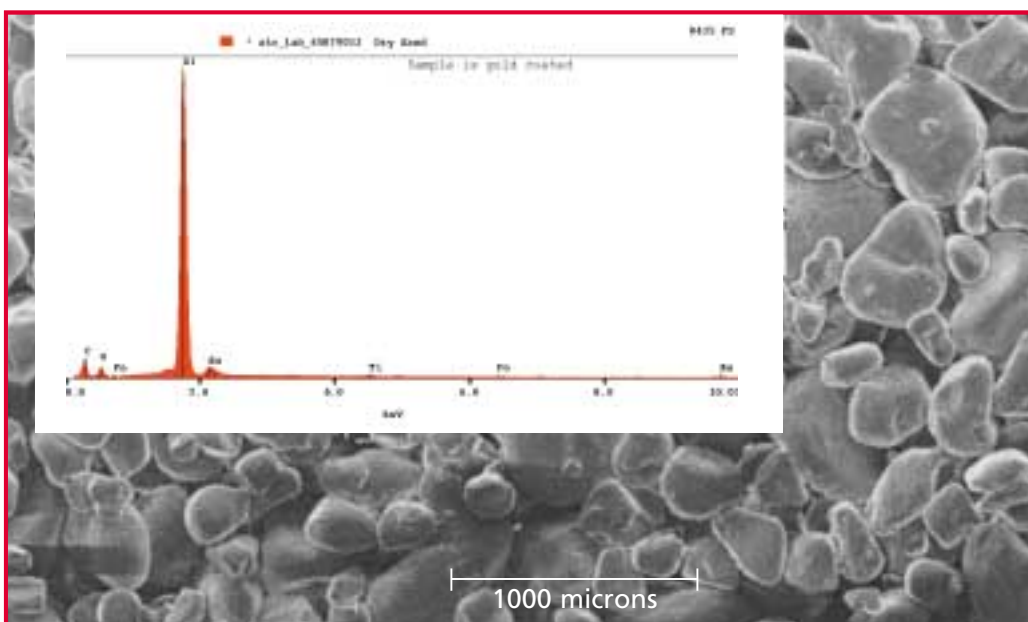
Figure 9 shows the typical grain structure of the dry sand core that is in contact with the casting surface. The chemical analysis shows that the sand is silica sand.

Figure 9: SEM image, and EDX spectrum of dry sand grains coming from the external surface of the dry sand core.

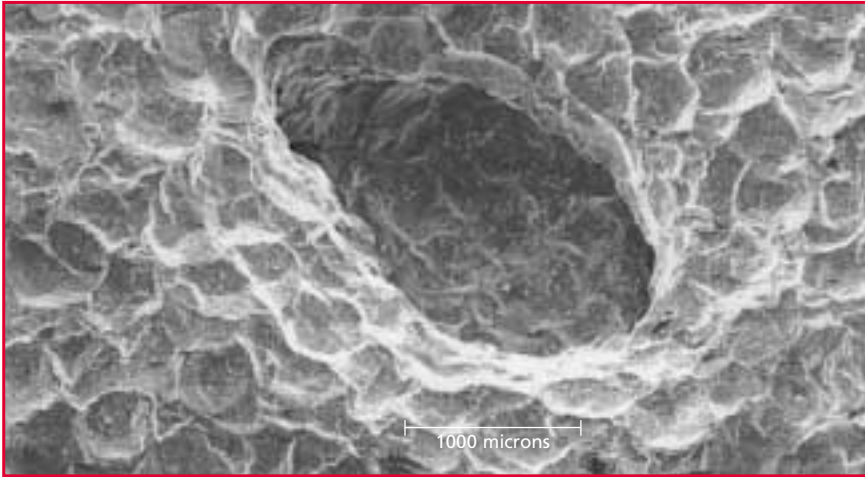
Figure 10 is a representative SEM picture of one of the four "oxide" defects that appeared at location "A" (lower surface of casting in contact with dry sand). As a result of the magnification, a better detail of the casting defect (void) can be observed. The casting surface around the void is very uniform: smooth surfaces without any breaking edge. It can also be noticed that the internal bottom surface of the void looks the same as the outside casting surface: relatively smooth. The similar appearance among surfaces would indicate that the same material that makes the outside surface created the defect (void). To confirm this theory, a surface topography and chemical analysis of both surfaces was conducted.

Figure 10: SEM image of the typical defect (void) and surrounding areas. This defect (hole) is a typical representation of similar defects in other castings. Photo is from a section of the casting in contact with dry sand core.

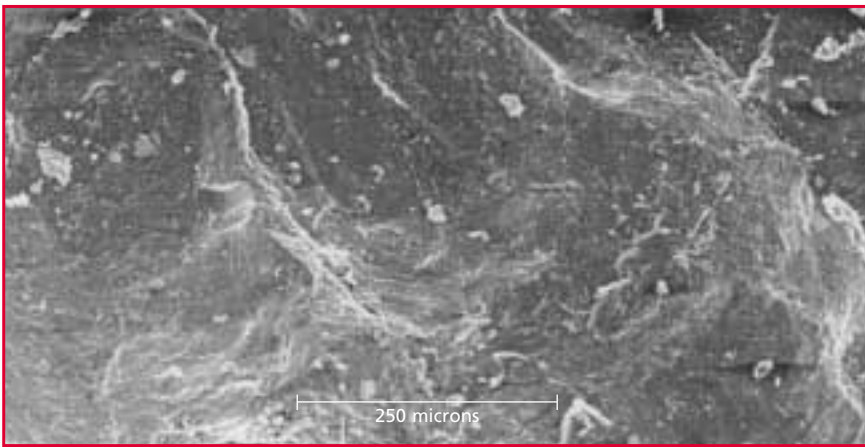
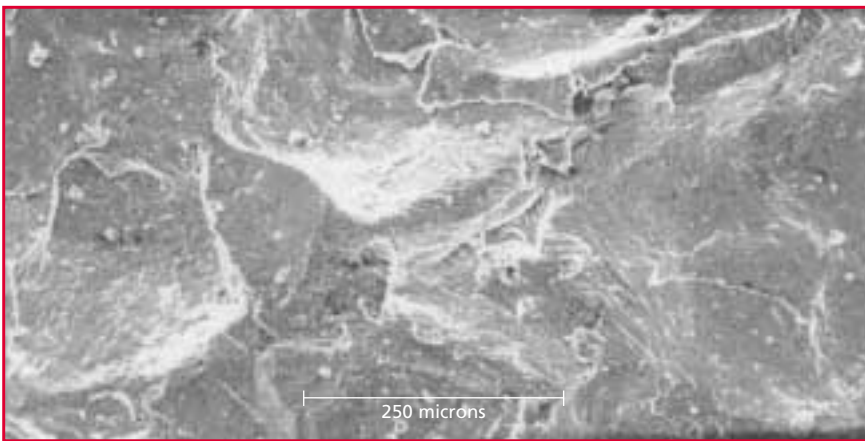
Figure 11 (for the inside hole) and 12 (for the outside surface) show that both surfaces are the same. By comparing Figure 10 with Figure 9 we can conclude that the dry sand grains caused the defect (void). Based on the analysis we must conclude that stickers in the dry sand core are causing voids in the casting surface. Therefore, the casting defect at location "A" should not be considered as an oxide.

Figure 11: SEM image of the inside area of the defect (void) depicted in figure 10.

Figure 12: SEM image of the outside area of the defect (void) depicted in figure 10. This image is a typical representation of the surrounding areas.

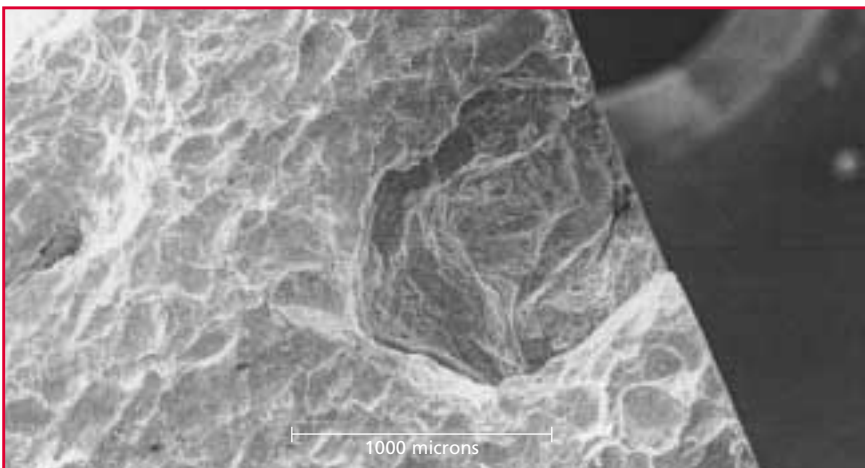
Figure 13 is another SEM picture from a different casting having a similar casting surface defect along location "A". For a more in depth analysis, the defect was sectioned also perpendicular to the outside casting surface. As before, by comparing this surface against the surface shown in Figure 9, it can be concluded that the same material that makes the outside surface caused the defect. Again, we must conclude that stickers in the dry sand core are causing the defect.

Figure 13: SEM image of a similar defect (void), as the one shown in figure 10, but in a different casting.

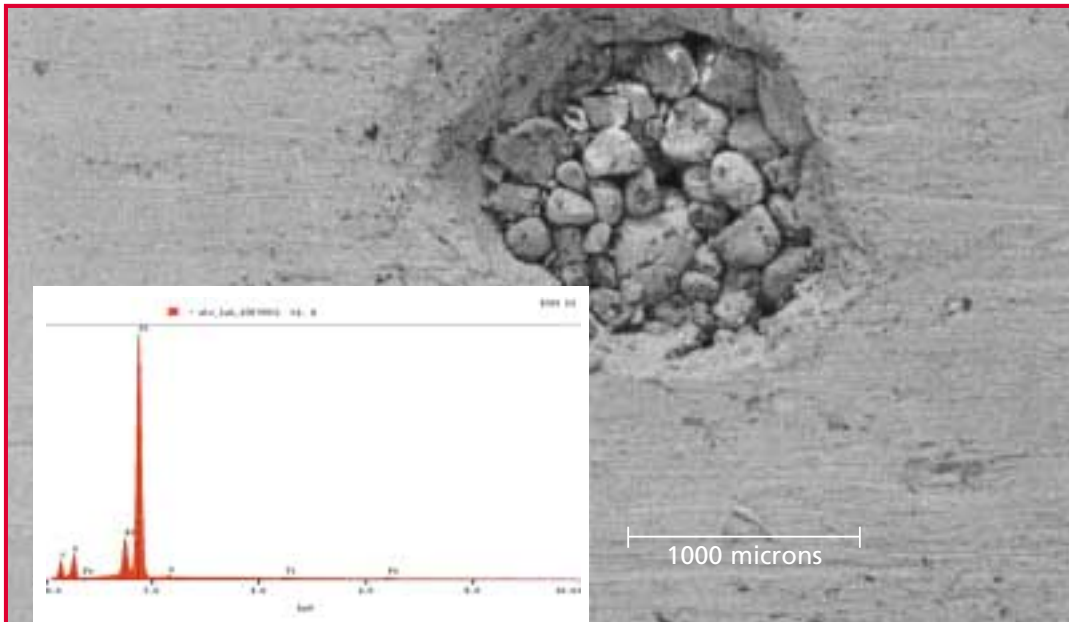
Figure 14 is a representative SEM picture of any of the seven "oxide" defects that appeared at locations "B" and "C". These locations are from upper and lower sections of the castings in contact with green sand mould material respectively. This picture clearly shows that the defect is due to green sand particles embedded in the casting. By comparing Figure 14 and Figure 8, it is clear that the defect is due to sand inclusions and not oxides.

Figure 14: SEM image, and EDX spectrum of the castings being scrapped for "oxides". Photo is from a section of the casting in contact with green sand mould material. As it can be seen the actual defect is green sand inclusions.

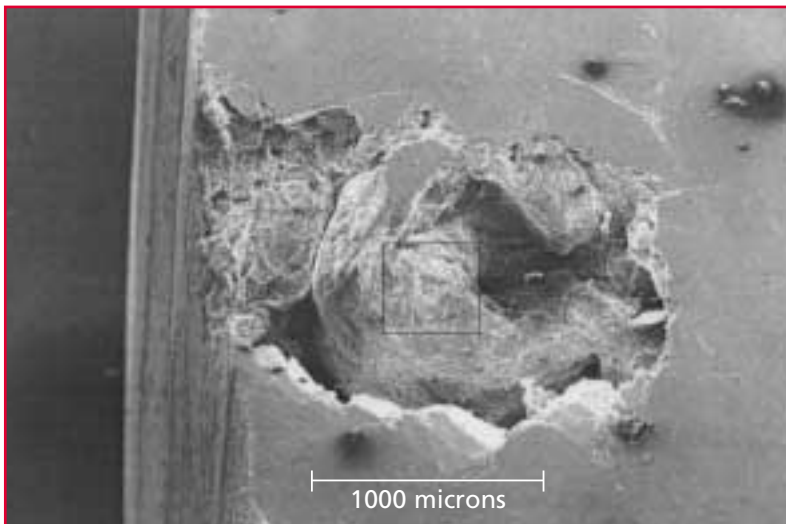
Figure 15 is a representative SEM picture of any of the four "oxide" defects that appeared at location "D" (upper surface of the casting in contact with green sand mould material). However, this picture shows that the appearance of the defect is different from the one shown in Figure 14. Figure 15 also shows that the morphology of the defect is quite different as compared to any of the previous morphologies shown in Figures 1, 4, 7, 8 and 9. A close up of Figure 15 is shown in Figure 16. Figure 16 depicts the defect topography as well as the elements present and their relative intensity. Based on these findings, this defect could be associated with molten metal turbulence.

Figure 15: SEM image of an open cavity (defect) normally being identified as oxide.

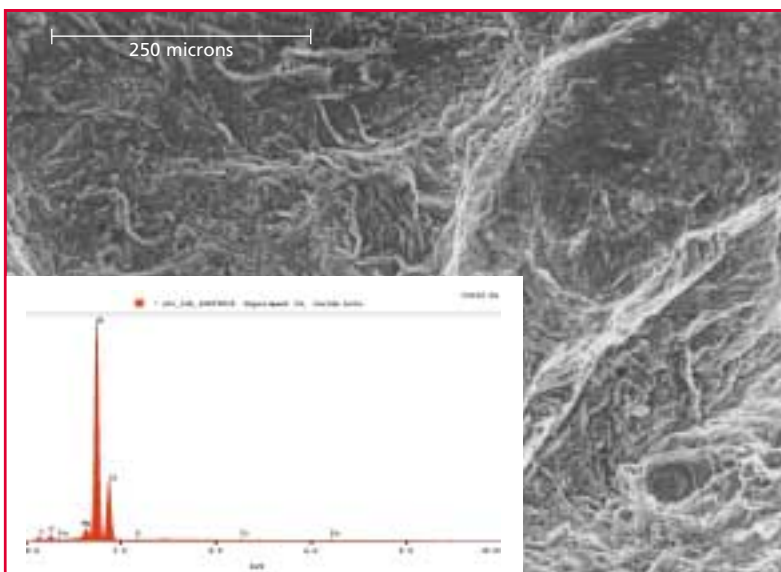
Figure 16: SEM image, and EDX spectrum of the defect shown in Figure 15, Indicating an oxide film.
